## Lesson #2

## Wide floodplains store water and help minimize flood damage

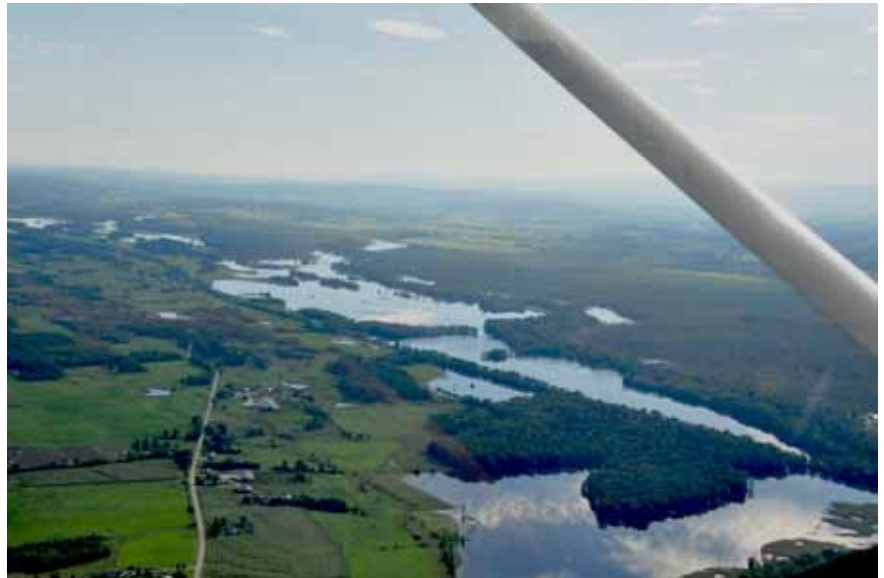
*A vast complex of wetlands sits along the Otter Creek between Rutland and Middlebury. The wetlands protected downstream communities by soaking up immense amounts of water during Irene. Photo by VTDEC.*

During Irene, the Otter Creek in Rutland swelled reaching a peak discharge of 15,700 cubic feet of water per second (cfs) and flood waters caused tremendous damage. Thirty miles downstream Middlebury is situated on the Otter Creek, but conditions there were quite different. The maximum peak discharge was only 6,180 cfs. Within four days the storm flow in Rutland had returned to normal, but in Middlebury flows did not even peak until then. Middlebury flows remained high for another two weeks and there was no flood damage! The dramatic differences in the Otter Creek at these two points can be explained by the presence of a vast, 9,000-acre complex of wetlands, in the floodplain of the Otter Creek between Middlebury and Rutland. The wetlands stored flood waters, slowly releasing them over time so that Middlebury and points downstream never experienced the full force of the flood. Businesses remained open and life went on as usual.

The massive scale of the Otter Creek Wetlands makes the lesson about the importance of floodplain storage more dramatic. Yet, there are numerous small-scale examples of berm removal and other stream channel and wetland restoration efforts intended to restore access to floodplains that also demonstrate the importance of maintaining and enhancing floodplain storage.

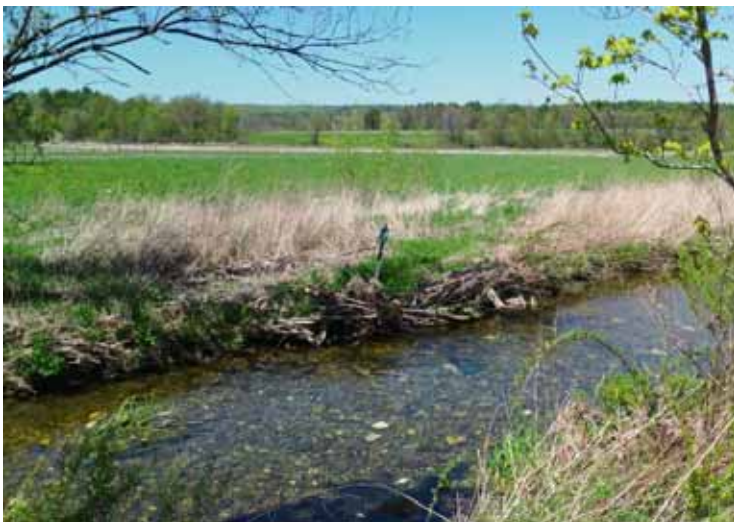
*Berm removal allowed access to extensive floodplains (top of photo) along the Indian River in West Pawlet at the Consider Bardwell Farm. Photo by Mike Winslow.*

In 2007, farm owners used conservation grants to remove 2,000 feet of a berm that constrained the Indian River to a narrow channel between the Delaware and Hudson Rail Trail and an old corn field, now pasture. Berm removal allowed the river access to extensive flood storage to the west. Areas downstream saw little damage during Irene – clearly the added flood storage helped.

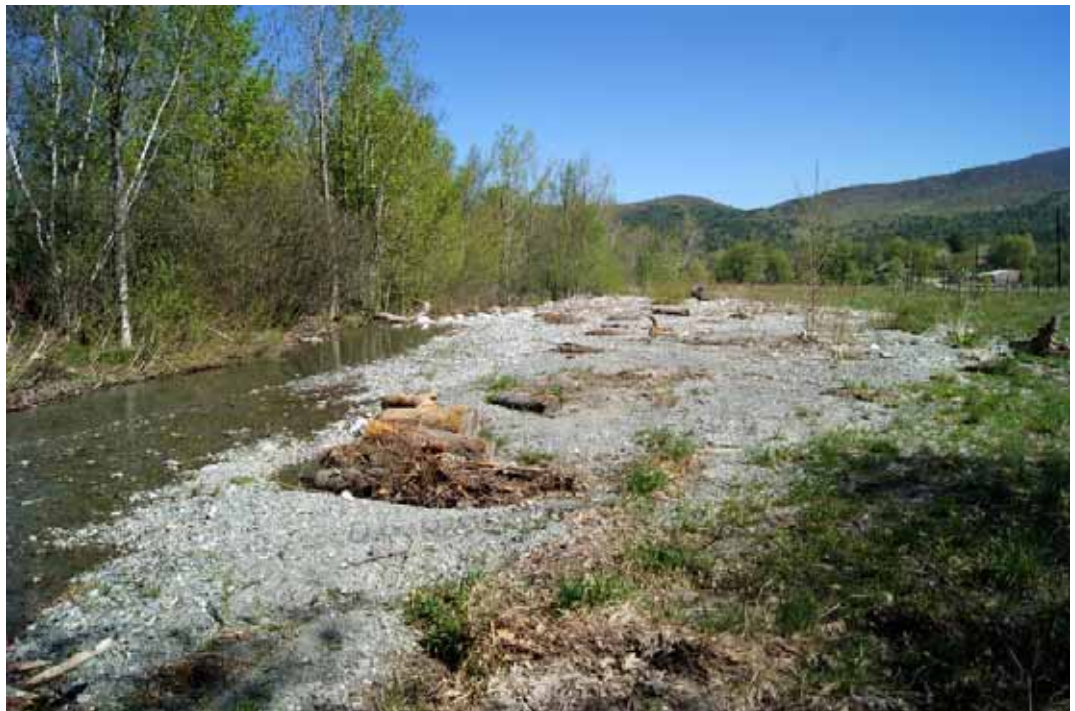
*A berm along the right bank of Gully Brook (far left of photo) was removed prior to the storm providing the river additional flood storage capacity. The white rocks in this photo were deposited in the restored floodplain during Irene. Photo by Lori Fisher.*

Berm removal also helped avoid flood damage along Gully Brook in Castleton. Gully Brook parallels Birdseye Road near its confluence with the Castleton River just south of Route 4A. At the point where the land around the brook levels off, the stream was bermed in 1959 to protect adjacent cropland and pasture. Berming increased the velocity of the water and its ability to carry sediment which the stream then deposited as it reached the Castleton River. Sediment accumulation led to regular flooding of the Traverse Farm barnyard and cattle pasture. The farmer found himself regularly removing sediment from the stream. Scientists from the Agency of Natural Resources suggested taking out the upstream berm to allow the river to deposit sediment where the berm was, thus reducing the risk of downstream barnyard flooding and the need to dredge the channel. The berm came out in 2004 and indeed land and property damage during Irene was minimal, as predicted. Property owner Bob Traverse told the Poultney-Mettowee Conservation District, “Gully Brook did as well as any stream in Vermont” during Irene.
