Lesson #1 Berms create a false sense of security

Lessons from the Floods

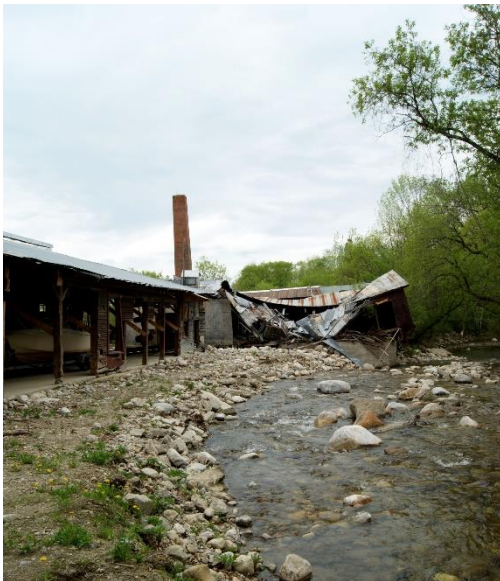
*The former Vermont Tubbs furniture factory in Forestdale. The factory was destroyed when the Neshobe River escaped a berm on the left bank.
Photo by Lori Fisher.*

Where the river channel narrowed, Irene's waters crashed through the berm. Portions of the Vermont Tubbs furniture factory were destroyed. The river carved two-foot ditches on either side of Newton Road, and gouged channels through corn fields, tearing away topsoil and leaving only gravel deposits. Basements filled with river water.

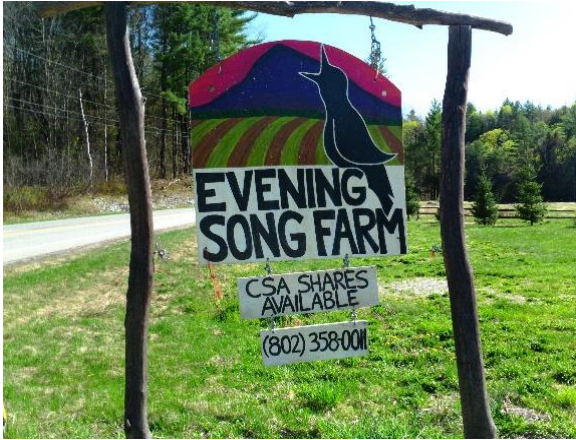
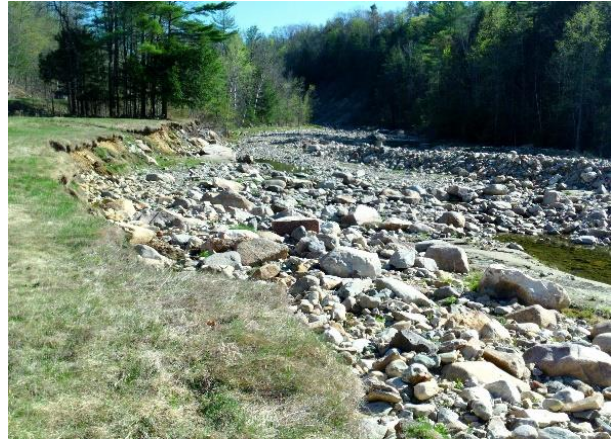
The Mill River (right) broke through its berm wiping out prime agricultural land at Evening Song Farm. Photos by Mike Winslow.

Evening Song Farm sits in the picturesque valley of the Mill River along Route 103 in Cuttingsville. The Mill River has been bermed at least three times to protect Route 103 and the railroad tracks that traverse the valley. During Irene, the river breached the berm upstream of Evening Song Farm. The main current of the Mill River roared across the farm's vegetable field, destroying the year's crop and leaving a boulder-strewn expanse. Farm owner Kara Fitzgerald told [Vermont Public Radio](#), "the river just eminent-domained my farm."

For river scientists, the destruction at Evening Song Farm was not a complete surprise. A river corridor management plan prepared prior to Irene noted how the river had been straightened and forced against the valley wall. The plan recommended removing the berm.

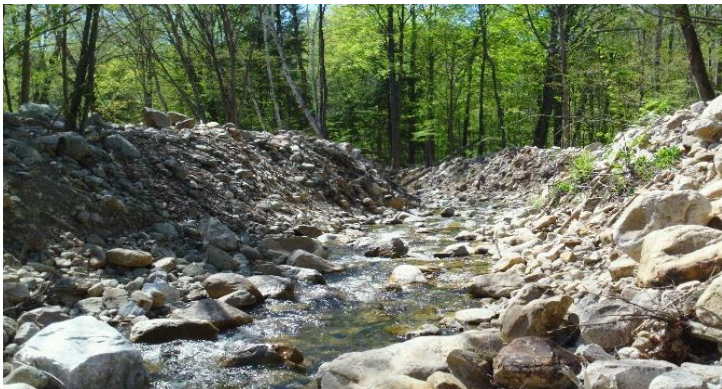
Berms along Homer Stone Brook gave local residents a sense they were safe from the water, but the brook escaped the berms during Irene. Photo by Mike Winslow.

Like the Mill River, Homer Stone Brook escaped from its berms during Irene, carving a new route to the Otter Creek. Once outside the berm, the river could no longer access its old channel. The new channel paralleled the railroad tracks for a few hundred feet before cutting underneath them to a new outlet. The railroad incurred hundreds of thousands of dollars in damage as a result. Despite this failure, the berms were reconstructed and heightened after the storm, and the river channel was narrowed even more.
