## Lesson #5

# When emergency measures create future dangers, go back and fix them

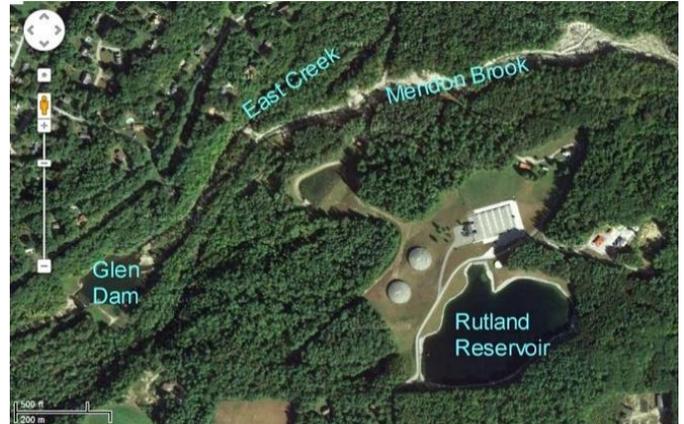
*Emergency measures to protect the Rutland water supply led to later sediment build-up in Glen Dam, a hydropower source. Affected parties worked together to go back and correct the problems.*

Emergency work ensued to stabilize a berm, protect the pump and inlet area, confine the brook to its channel, and ensure a stable water supply. Bulldozers windrowed the river channel creating nine-foot high levees on either side of the stream. It took almost a month to get the water intake functioning again, but eventually the reservoir began to refill.

The work that occurred on Mendon Brook in the immediate aftermath of Irene was clearly necessary, but it also created problems. The brook lost access to floodplains between it and East Creek, making future flooding potentially more dangerous. The channelization of the stream increased its velocity and transport capability. Excess sediment settled out in the Glen Dam impoundment.

CVPS/GMP worked with Rutland and the Department of Environmental Conservation to reconfigure some of the stream alterations that had taken place under emergency conditions. They lowered berms, brought large debris into the stream channel to help slow the water flow, and opened floodplain access along the river bank opposite the drinking water intake. While the stream still shows clear signs of channelization, the future flood risk has been reduced.

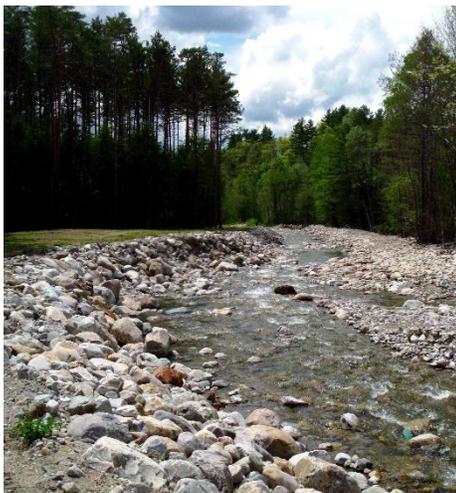
*The Mendon Brook near the Rutland water intake jumped the left bank near this spot threatening the intake. Photo by Lori Fisher.*

Raging floodwaters in Mendon Brook threatened the water supply system for Rutland during Irene. Water treatment plant supervisor Michael J. Garafano and his son Michael G. Garafano lost their lives when they went to check on the intake during the storm. The flood destroyed the water intake, plugging it with debris and rock, and forcing the utility to rely on a back-up on East Creek. At one point the city was down to a 13-day supply of water; its reservoir typically holds a 30-day supply. The backup system helped to refill the reservoir for a few days, but eventually the East Creek water levels dropped too low to be used. The city faced an emergency situation, and needed to reopen the Mendon Brook intake as quickly as possible.
