Lesson #1 Berms create a false sense of security

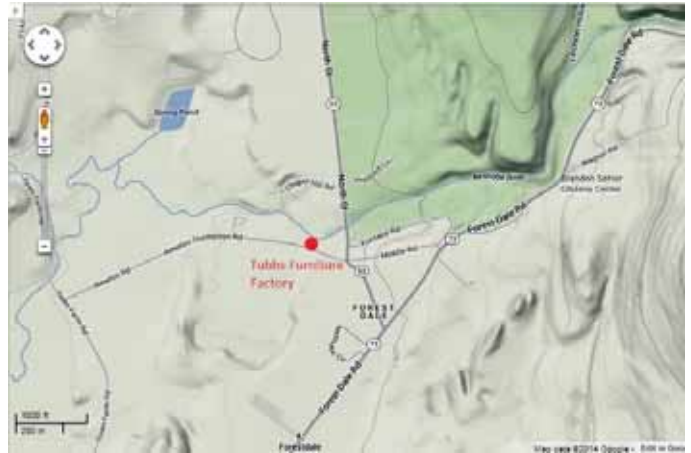
The Neshobe River flows from the west face of the Green Mountains before passing through Forestdale.

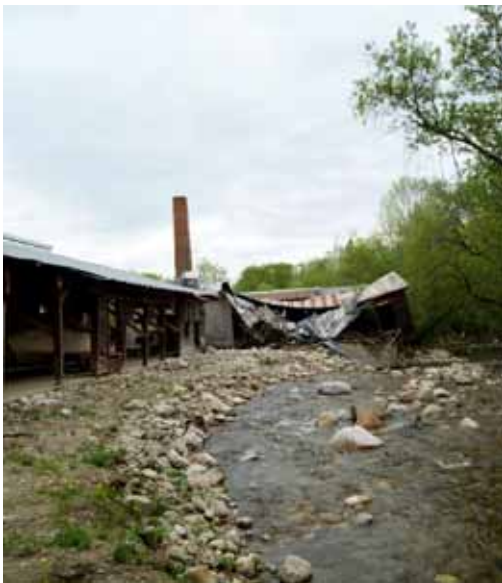
The former Vermont Tubbs furniture factory in Forestdale. The factory was destroyed when the Neshobe River escaped a berm on the left bank. Photo by Lori Fisher.

Where the river channel narrowed, Irene's waters crashed through the berm. Portions of the Vermont Tubbs furniture factory were destroyed. The river carved two-foot ditches on either side of Newton Road, and gouged channels through corn fields, tearing away topsoil and leaving only gravel deposits. Basements filled with river water.

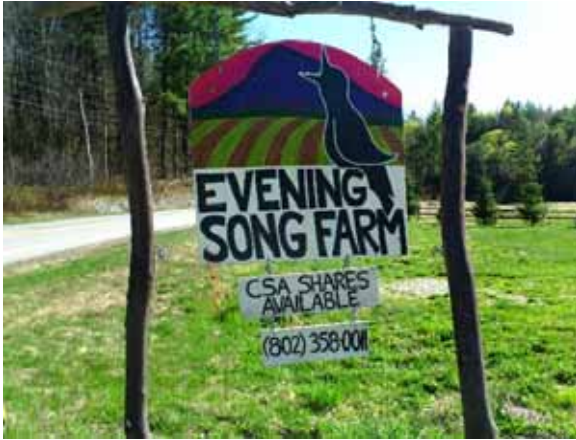
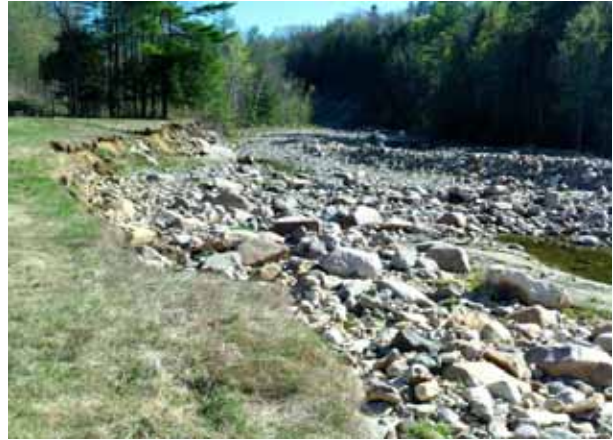
The Mill River (right) broke through its berm wiping out prime agricultural land at Evening Song Farm. Photos by Mike Winslow.

Evening Song Farm sits in the picturesque valley of the Mill River along Route 103 in Cuttingsville. The Mill River has been bermed at least three times to protect Route 103 and the railroad tracks that traverse the valley. During Irene, the river breached the berm upstream of Evening Song Farm. The main current of the Mill River roared across the farm's vegetable field, destroying the year's crop and leaving a boulder-strewn expanse. Farm owner Kara Fitzgerald told Vermont Public Radio, "the river just eminent-domained my farm."

For river scientists, the destruction at Evening Song Farm was not a complete surprise. A river corridor management plan prepared prior to Irene noted how the river had been straightened and forced against the valley wall. The plan recommended removing the berm.

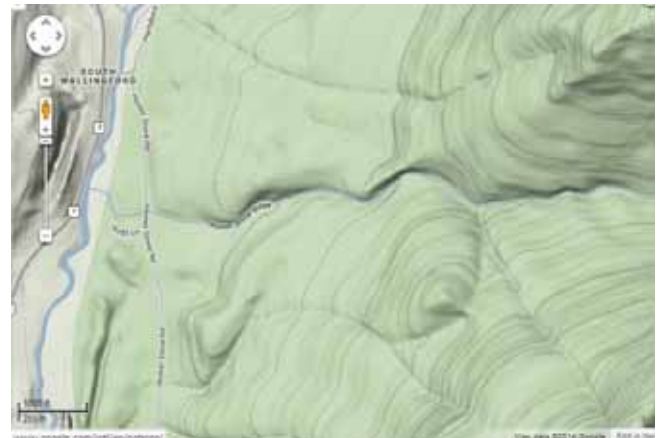
Homer Stone Brook drops over 1,200 feet between Little Rock Pond and the Otter Creek.

Other communities insist on rebuilding berms. Homer Stone Brook in Wallingford drops over 1,200 feet along its approximate two-mile length from its origins at Little Rock Pond on Green Mountain to its confluence with the Otter Creek. In the last one-sixth of that route, the brook's course flattens. Here berms were constructed to prevent the brook from fanning out to homes and railroad tracks that cross it downstream.

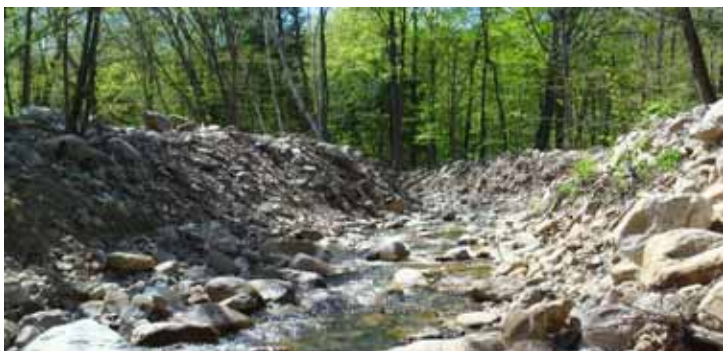
Berms along Homer Stone Brook gave local residents a sense they were safe from the water, but the brook escaped the berms during Irene. Photo by Mike Winslow.

Like the Mill River, Homer Stone Brook escaped from its berms during Irene, carving a new route to the Otter Creek. Once outside the berm, the river could no longer access its old channel. The new channel paralleled the railroad tracks for a few hundred feet before cutting underneath them to a new outlet. The railroad incurred hundreds of thousands of dollars in damage as a result. Despite this failure, the berms were reconstructed and heightened after the storm, and the river channel was narrowed even more.
